Manhole Inspection Summary

Manhole # S45K__042MH

Insp Date: **4/30/08 1:23 PM**

Location Address: **604 s washington st**

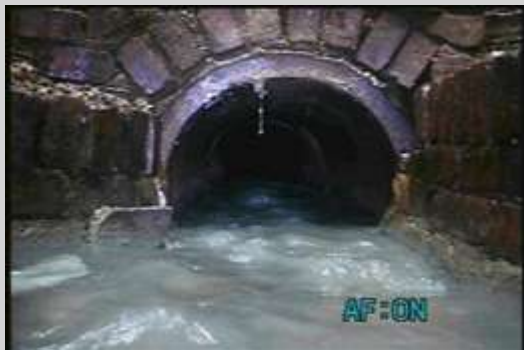
12 O'Clock Outflow

15 in. Circular Gravity Sewer
Pipe Out @ 12 O'Clock

Deposits: ☒ None ☐ Mud ☐ Sludge ☐ **Debris** ☐ Grease

Infiltration: **None** Pipe Seal Cond: **Unknown**

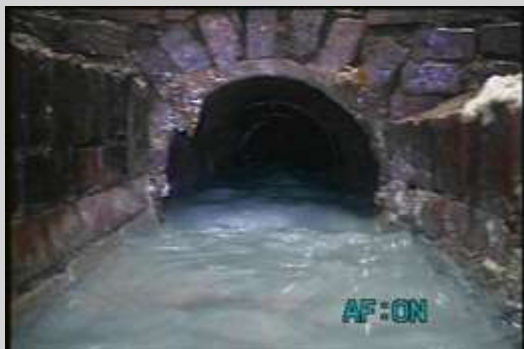
6 O'Clock Inflow

15 in. Circular Gravity Sewer
Pipe In @ 6 O'Clock

Deposits: ☒ None ☐ Mud ☐ Sludge ☐ **Debris** ☐ Grease

Infiltration: **None** Pipe Seal Cond: **Unknown**

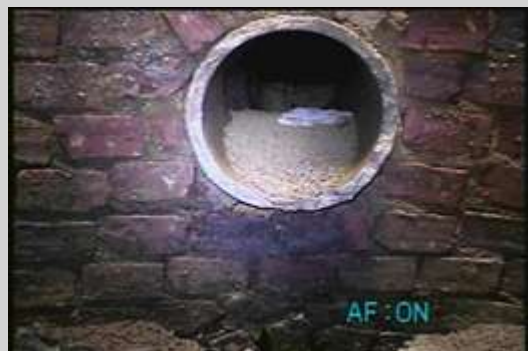
9 O'Clock Inflow

8 in. Circular Gravity Sewer

Pipe In @ 9 O'Clock

Deposits: ☐ None ☐ Mud ☐ Sludge ☒ **Debris** ☐ Grease

Silt Depth: **3** (in.) Deposits Extent: **Medium**

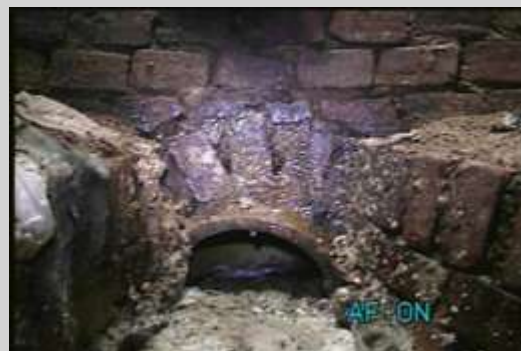
Drop In @ 9 O'Clock

Drop: **Outside** Direct

Drop Condition: **Partly Clogged**
